COMBAT *Cub*

REBUILDING L-4H 43-30430/11721

BY DAVID WOODCOCK

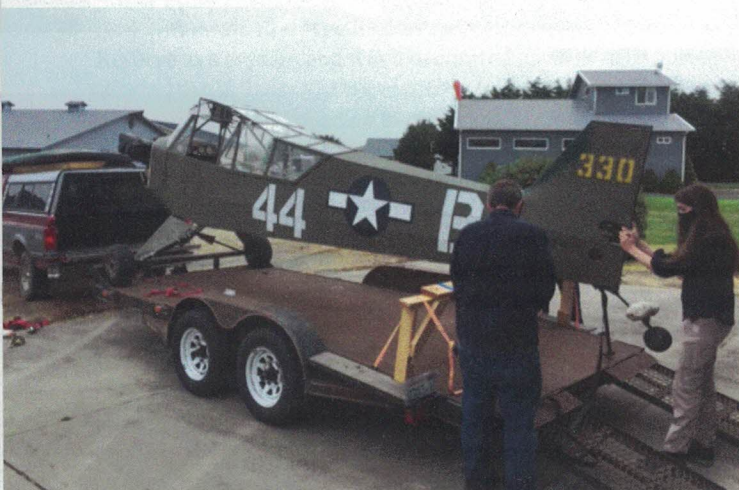
Kevin and Rose secure the tail to the trailer.

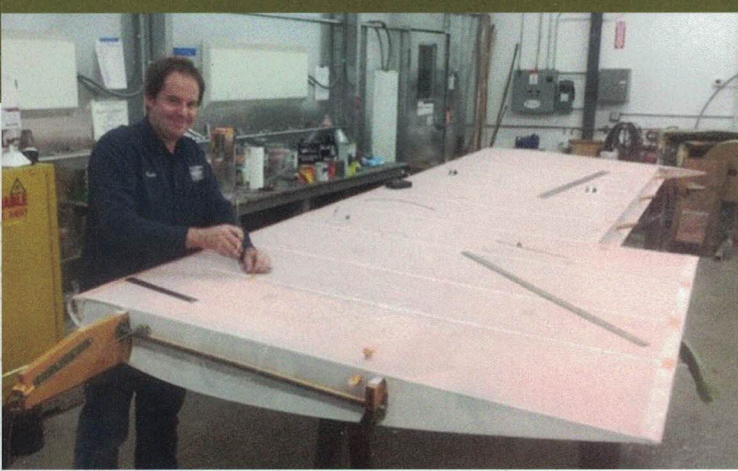
Kevin Vogel demonstrating the fine art of rib-stitching.

We found that the ailerons had not been rib-stitched the last time they were re-covered, and the left aileron had been previously damaged and not properly repaired. It had to be replaced. During this time, Mike removed the fabric from the horizontal tail surfaces and found significant corrosion that needed to be repaired before the surfaces could be re-covered.

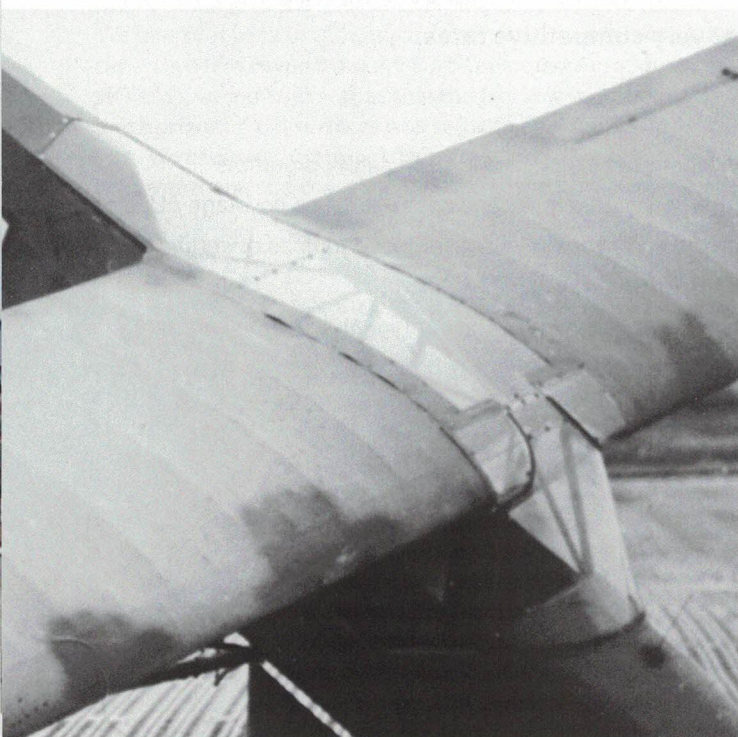
Showing the Plexiglas turtle deck.

To counter attacks from German fighters, many L-4s had the metal leading-edge wing to fuselage “eyebrow” fairings replaced with Plexiglas to increase the pilot’s visibility. From 1944 to 1945, the 9th Army had the 50th Mobile Reclamation and Repair Squadron install these frequently on its L-4s. After looking at many wartime photos of L-4s that featured these modifications, I contacted Paul Smith, who referred me to Keri-Ann Price, a talented L-4 builder in New Hampshire who had made form blocks for the Plexiglas. I purchased a set and was impressed with the quality and perfect fit. It was immediately obvious when sitting in the front pilot’s seat how effective this addition was.

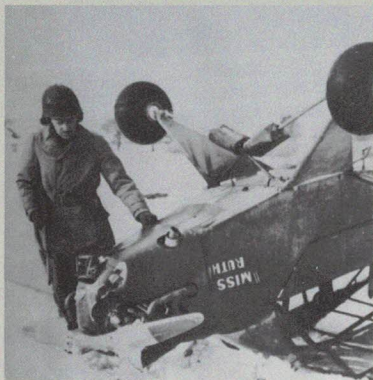
This L-4 overturned while landing in snow. *National Archives photo*

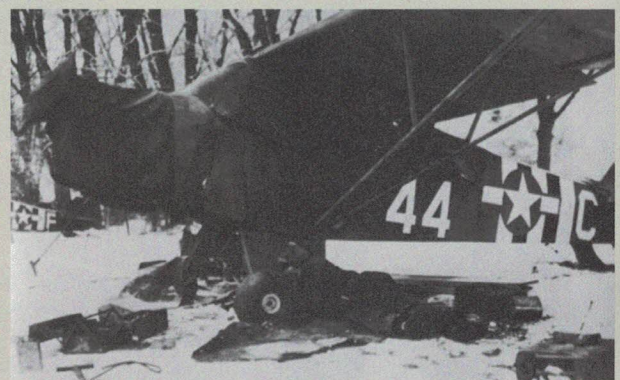
Left brake maintenance and repair. Francorchamps, Belgium, January 7, 1945. The number 44 is the identifier for the 30th Infantry Division. The letter C designates one of the 12 battalions it was assigned to. *Photography by Maj. C.W. Lefever*
